Gamma radiation damage study of 0.18 m process CMOS image sensors

Gamma Radiation Damage Study of 0.18 μm Process CMOS Image Sensors

Keywords: CMOS, 5T, leakage current, non-uniformity, radiation damage, gamma irradiation.

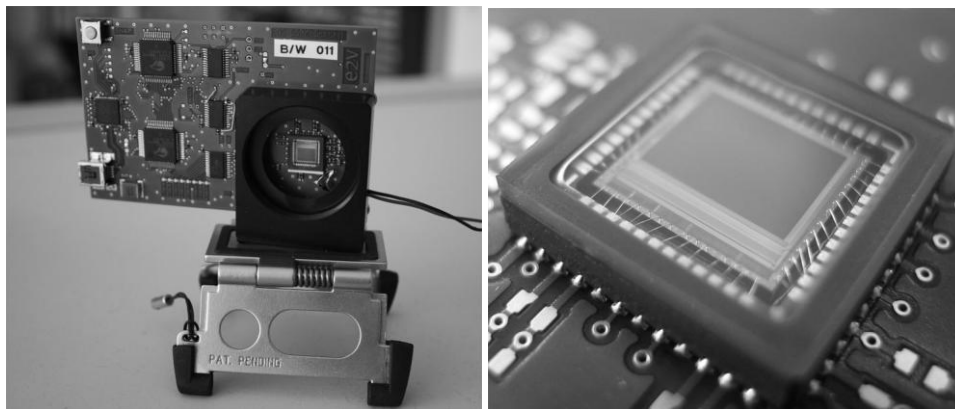
Figure 1. Photographs showing the CMOS chip on demonstration board (left), and close-up of the chip (right)

The imagers used for this study are 0.5 Mpixel arrays of $5T\ 6 \times 6\ \mu\text{m}$ pixels, manufactured using a $0.18\ \mu\text{m}$ process, and were provided by e2v technologies plc. based in Chelmsford, UK. Examples of the chip and readout boards are shown in Figure 1. The pixels have no advanced structures designed to mitigate radiation damage, so the results of this study will show a baseline of radiation hardness for the design and process used.

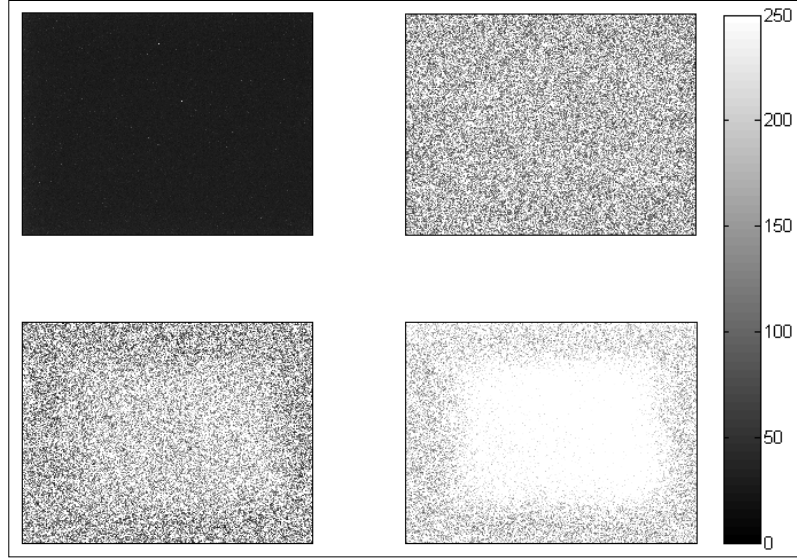
Figure 3. Still frames obtained during Co^{60} irradiation of chip BW 206 at 0 krad(Si) (no gamma flux), 0 krad(Si) (gamma flux incident), 30 krad(Si) (gamma flux incident), and 80 krad(Si) (gamma flux incident). (Top left, top right, bottom left, bottom right, respectively).

Figure 3 shows several images captured during the irradiation of chip BW 206. The gamma flux is apparent as a uniform noise across the whole sensor. As the irradiation progresses, it becomes apparent that the signal in the centre of the imaging area is increasing at a greater rate than that in the border of the imaging area, as the uniform gamma flux becomes more and more non-uniform, a similar effect is seen in some STAR-250 irradiations^[8]. As the dose approaches 120 krad(Si), the device becomes completely saturated over the whole device. At this point in the irradiation, communication with the device were lost, either due to a failure of the chip, or due to failure in the un-shielded area of the readout board.

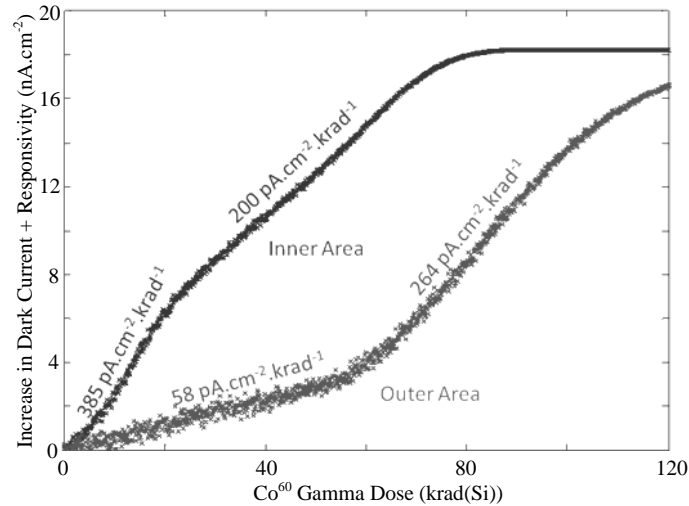
Figure 4. Measurements of the dark current for inner bright area, and outer area, during irradiation.

Figure 4 shows measurements taken at intervals of 0.1 krad(Si) during the irradiation, and plotted as an average over the inner and outer areas of the device. The inner area of the device shows a much higher increase in non-uniformity of the signal than the outer area, especially for the first 25 krad(Si). The outer area, in contrast, shows a high degree of radiation hardness up to 60 krad(Si), then begins to become damaged more quickly, equalling

or exceeding the rate of damage experienced by the inner area. The device becomes fully saturated at around 80 krad(Si) in the inner area, hence the slope returning to 0 at that point.

Figure 6 shows the dark current measured at different stages during the irradiation of chip BW 204. It can be seen that much lower dark current figures are measured than were seen in Figure 4, which suggests that much of the increase in non-uniformity is due to an increase in either responsivity to the gamma radiation, or damage to the readout board. However it's also clear that the non-uniform increase in dark current is still a factor, as the inner area of the image area increases in dark current more quickly than the outer area (and shows a very large jump between 15 and 20 krad(Si)). This plot also shows the radiation hardness of CMOS technology, with even the inner area showing an increase in dark current of only $2 \text{ pA.cm}^{-2}.\text{krad}(\text{Si})^{-1}$. We can compare this to a similar CCD not optimized for radiation hardness such as the e2v CCD57-10, which in partially inverted mode showed an increase in dark current of $30 \text{ pA.cm}^{-2}.\text{krad}(\text{Si})^{-1[9]}$. The outer area shows an even lower measurement of $1.5 \text{ pA.cm}^{-2}.\text{krad}(\text{Si})^{-1}$ with no sudden jump after 15 krad(Si).

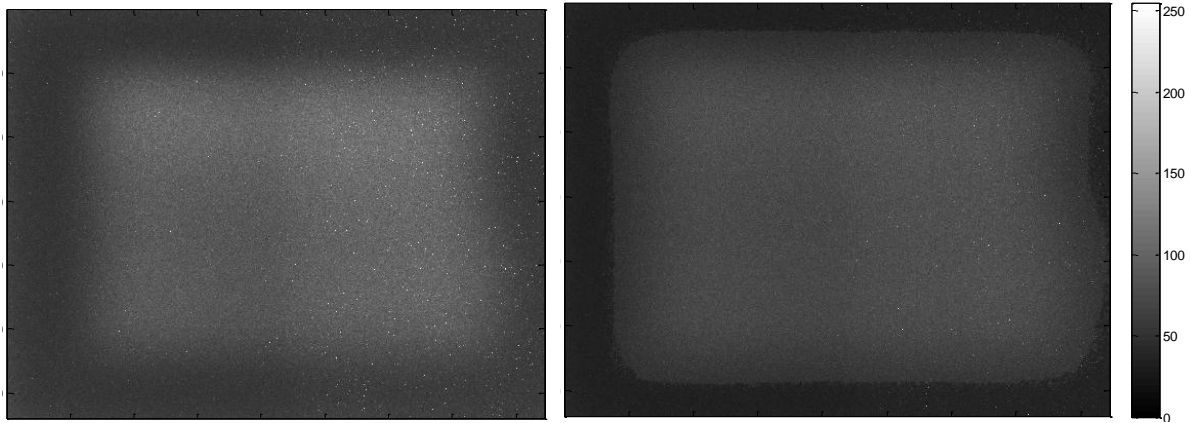
Figure 5. Dark image of chip BW 204 showing dark current non-uniformity immediately after 20 krad(Si) of irradiation (left), and after a further 6 months of annealing at room temperature (right).

Figure 5 shows the dark current pattern on a chip irradiated to 20 krad(Si) before and after 6 months of annealing at room temperature. The non-uniformity is very similar to that shown in the previous test to 120 krad(Si), and the bleeding on the right hand side of the images can be explained by prior irradiation by protons on the right hand side of the chip. It can be seen that after anneal, the dark current pattern becomes much less diffuse, and resembles glue or some similar material providing dose enhancement effects.

However, the device has been analysed for any non-uniformity of dose over the device due to underlying structure or shielding effects. No match has been found between the positioning of this dark current non-uniformity and any structural feature on the chip. As the dark current non-uniformity is central to the uniformity, and the position of the imaging area is not central to the chip (see figure 1), this suggests that the pattern of radiation damage is central to the manufacture of the imaging area, and not due to any shielding or enhancing effects. The actual reason for the enhanced dark current in the centre of the device is not understood – and is suspected to be due to the manufacture of the imaging area at the foundry level.

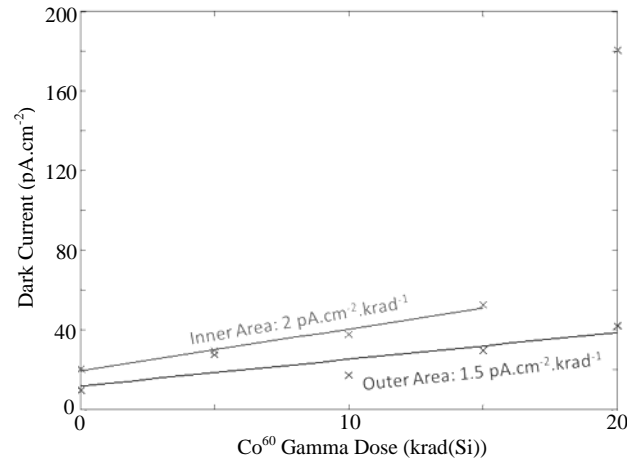
Figure 6. Plot showing average dark current with increasing radiation dose over the inner area (grey), and outer area (black)

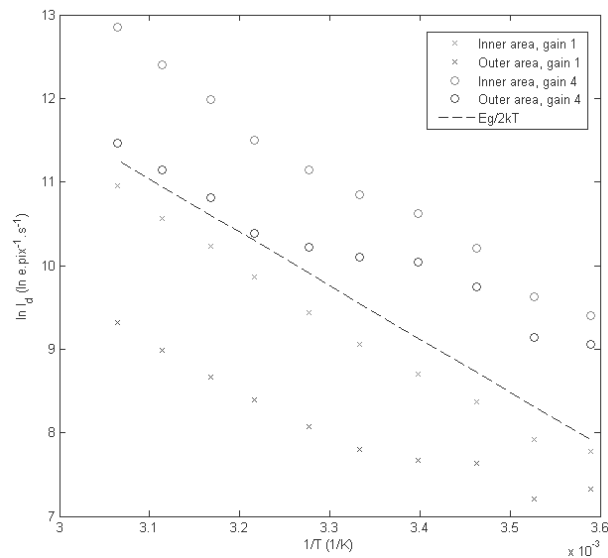
Figure 7. Shows behaviour of $\ln I_d$ against $1/T$ for inner and outer areas (circle and cross markers) at gains of 1 and 4 (black and grey)

Figure 7 shows that, in both regions of the imaging areas, the dark current follows the relationship:
